# Case Study

## Machine Company Floor Void Fill

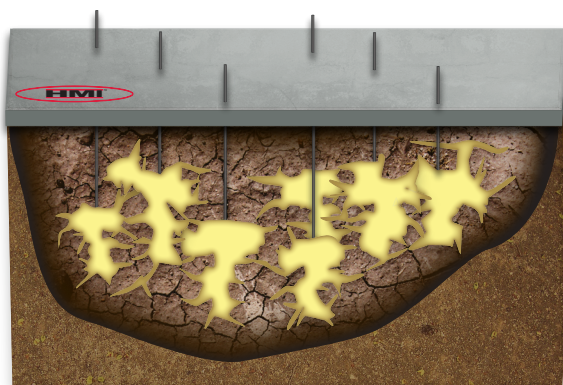
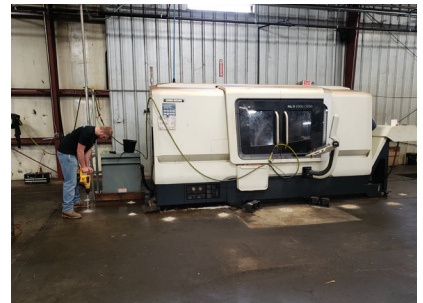
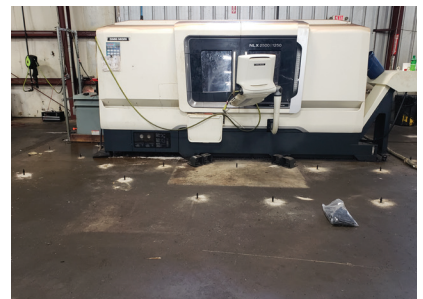
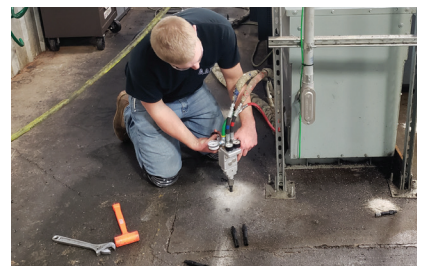
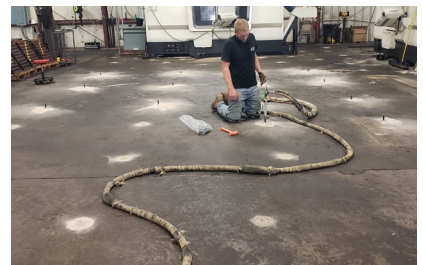
A one inch void was found under the slab due to erosion; The shop was built on marshland. This allowed for no support causing the slab to deflect significantly.

Advanced American Flooring Inc. was called and the work was completed in 6 hours. Using the EliteOne gun and HMI's 501 polyurethane foam the void was filled, which stabilized the concrete slab. 501 polyurethane foam was chosen for this job because it provides a slower reaction time and further spread. Due to the distance this foam can travel, 501 is excellent for undersealing and stabilizing joints on rocking slabs from slab curl. The same dial gauge test was performed after the foam was injected, and showed no deflection. The CNC's were re-leveled and operations continued. The only alternative would have been to tear out, and replace the entire slab. Which would have affected production greatly. By choosing to fill the void, they were able to continue production immediately following the repair.

853 lbs of HMI 501 stabilizing polyurethane foam
